CARR-1258

Maintenance Shop

Springfield Hospital Center

Maryland Historical Trust State Historic Sites Inventory Form

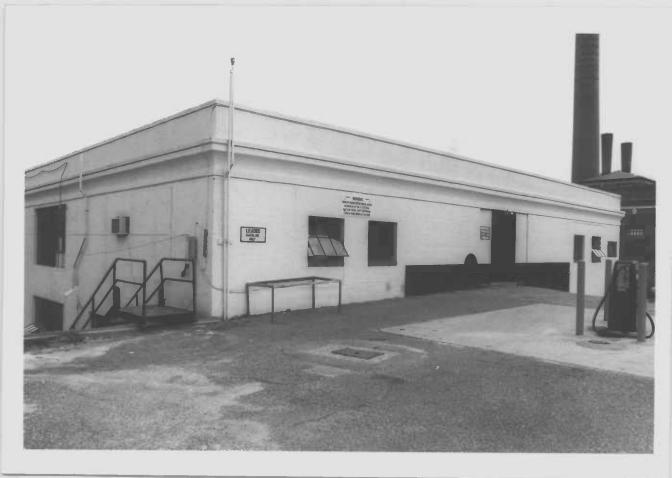
CARR-1258
Maintenance Shop
Springfield Hospital Center
Sykesville, Maryland
Don Jewell, 6/86
Negatives at MHT
West and North Face

The Maintenance Shop is a one story, stucco building measuring eight bays long and four bays deep. Located just north of the Powerhouse, the main facade looks west. Because the building rests on the side a hill, the basement level is visible on the north, south and east facades. A flat roof covers the structure.

The fenestration pattern on the west wall has been altered. The ghosts of the larger, original windows are visible. The austral windows display a brick sill, metal surrounds and single sash. A product of the 1920's, austral windows were often used in public buildings for increased ventilation. The remaining fenestration on the other walls consists of large, multipaned pivot windows with metal surrounds and mullions. The pivot windows are slightly recessed and lack any sill or lintel.

The main entrance on the west wall has also been altered to a set of doors. wooden doors are adorned by a large surround. A raised string course runs above the doorway and could be considered as a lintel for the door. The stucco wall bows outward slightly to form the cornice. A short parapet rises from the flat roof and frames the building.

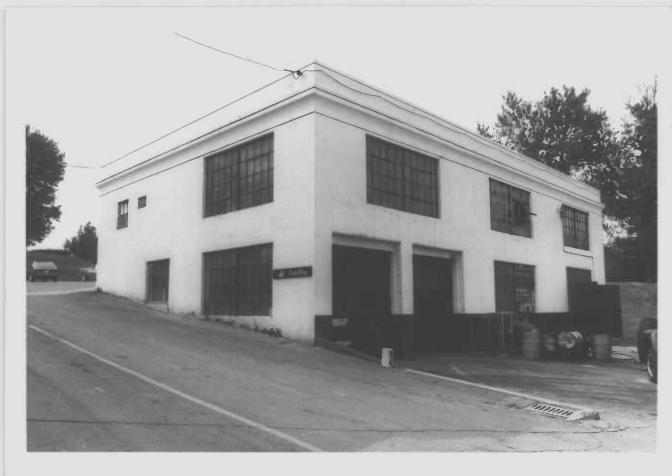
CARR-1258
Maintenance Shop
Springfield Hospital Center
Sykesville, Maryland
Don Jewell, 6/86
Negatives at MHT
East and South

The east wall repeats the large metal windows. In addition, the ground level exhibits two large openings for retractable garage doors. The wooden doors operate on metal tracks. A common pier divides the openings. The area functions as an auto shop. A single door appears on the northern end of the wall. It displays a large wooden transom. The opening contains a door within a door and both open outward away from the building.
